Galley and Overhead Compartment Experiment Results - Full-Scale Transport Controlled Impact Demonstration

Roger M. Lloyd
RMS Technologies, Incorporated
Trevose, Pennsylvania

December 1985

1. Report No. DOT/FAA/CT-85/33	2. Government Accession No.	3. Recipient's Catalog No.	
4. Title and Subtitle Galley and Overhead Compartment Experiment Results - Full-Scale Transport Controlled Impact Demonstration		5. Report Date December 1985

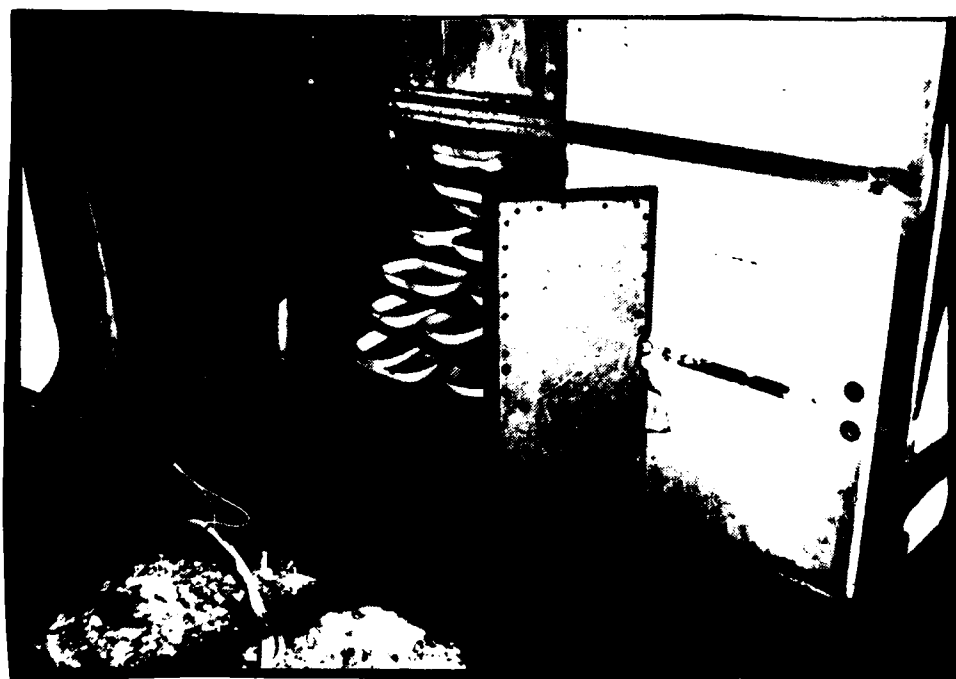
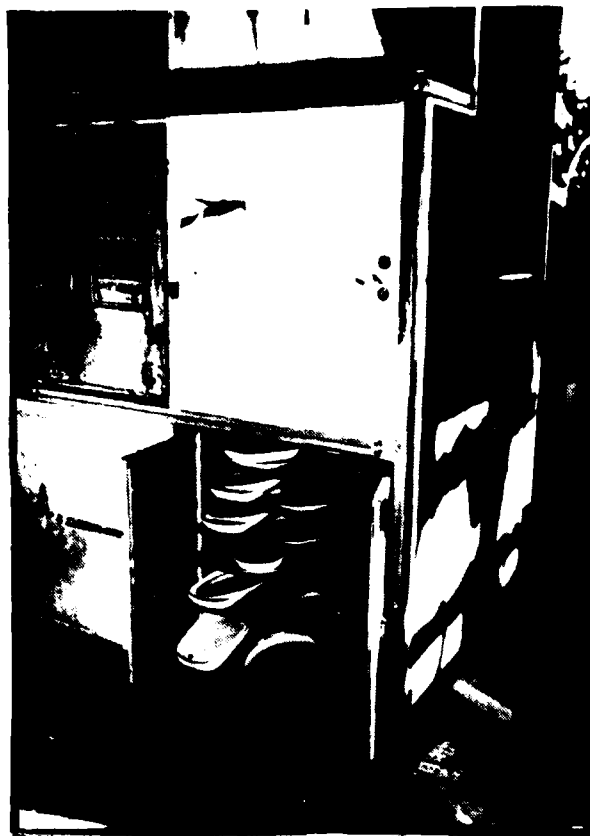
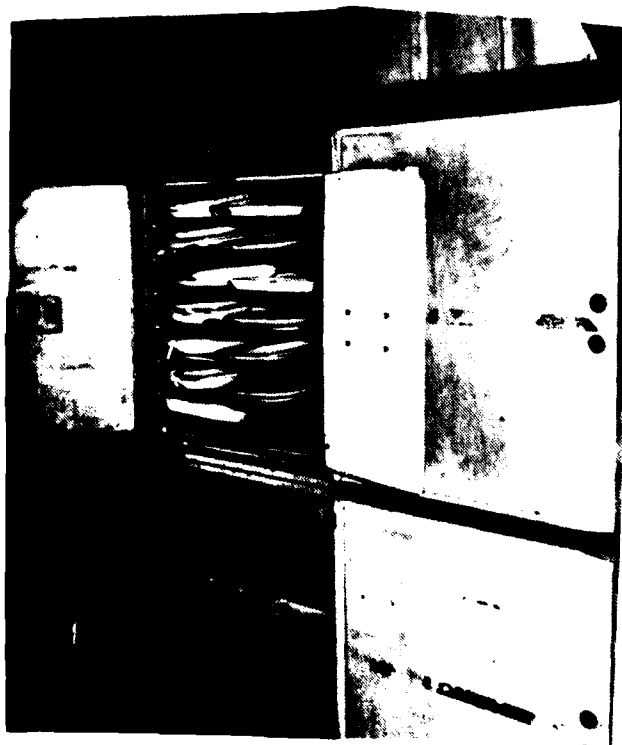
Post-test examination of the galley modules also revealed that the interior latching devices and exterior sliding galley restraint doors, performed satisfactorily without loss of interior contents and equipment. The galley interior and container equipment showed evidence of smoke residue due to the fire. Also, minor chips on some of the dishes were noticed. the forward galley performed equally well. Notwithstanding that the hazardous material packages were ignited by the lower cargo compartment fire and that some of the packages were damaged by the fire crew, there appeared to be no evidence of prior impact damage to the forward galley or interior contents (see figures 28 through 30).

FIGURE 28. AFT GALLEY CHINA POST-CRASH

FIGURE 29. AFT GALLEY CHINA, TRAYS POST-CRASH (LOWER)

FIGURE 30. AFT GALLEY CHINA, TRAYS POST-CRASH (UPPER)

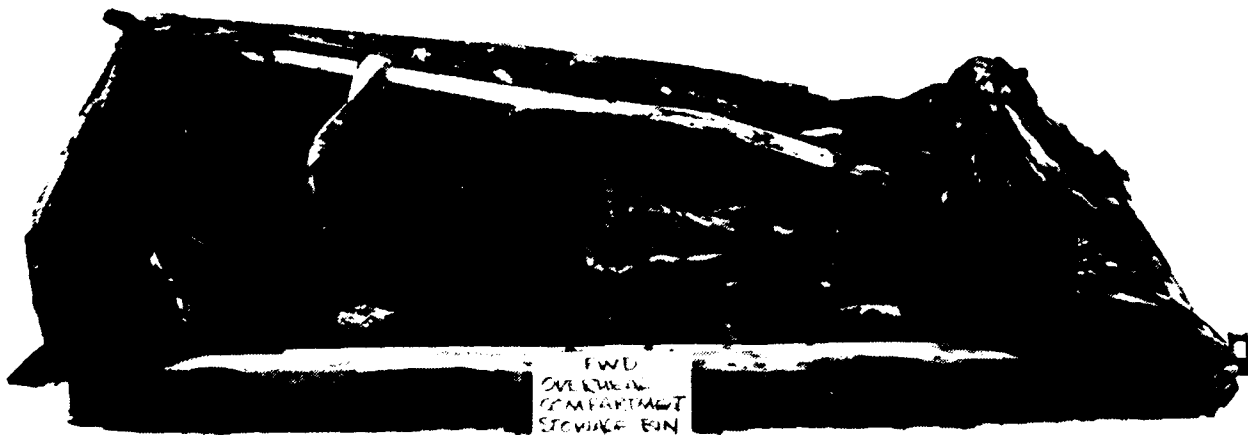
remained in place during the crash and slide out. However, both compartments were found in the lower cargo area severely damaged by fire when the aircraft was entered after the crash. As may be seen in figure 31 and 32, the compartments were heavily damaged by fire. There are some questions about the failures of the support links. The remains of the support links were examined by the metallurgy laboratory at the Naval Air Development Center, Warminster, PA., to determine if the failures were due to the heat from the fire and/or if they could have failed structurally during the crash. The laboratory report is included as Appendix A to this report. The laboratory results concluded that all of the failures were due to the fire. However, there is some evidence indicating that some of the support links may have broken during the initial impact, while not to the extent that would have allowed separation of the compartments.

FIGURE 31. FORWARD OVERHEAD COMPARTMENT POST-CRASH

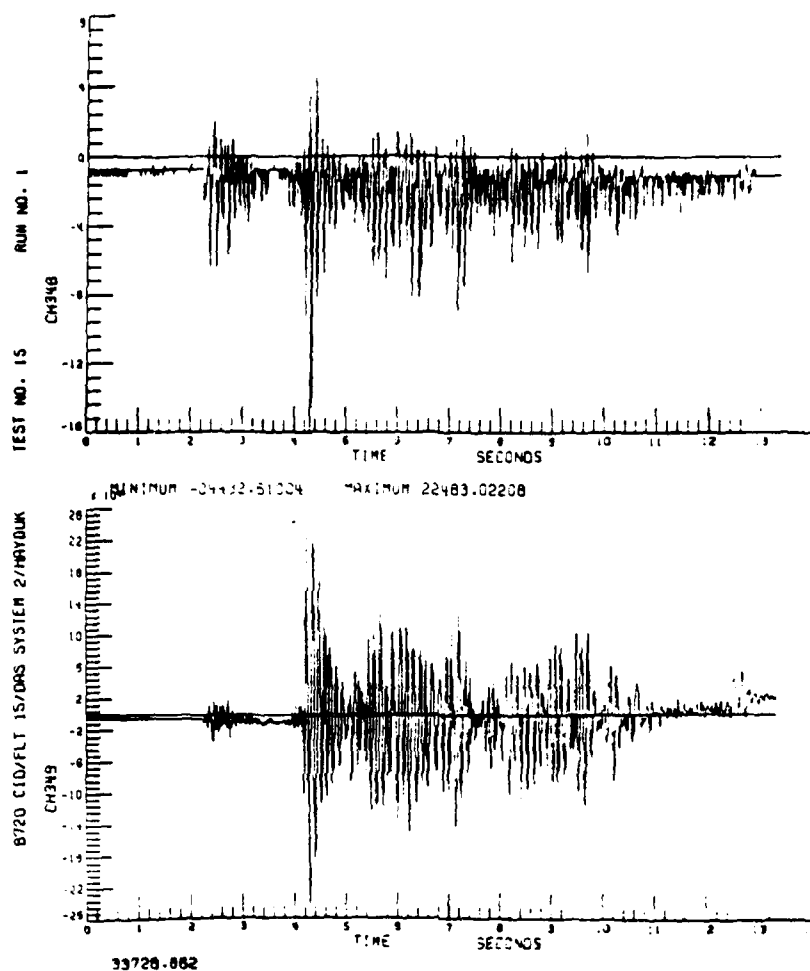
In figure 33, an identification of the pre and post-impact loads across the upper (channel 348) and the lower (channel 349) instrumented support links are shown. Notwithstanding that the identified loads in the lower link are undetermined due to a drift in the data (cause unknown), the relative variation of loads in the upper link after the crash is about 60 percent greater than before the crash. It is believed that this increase in load as carried by the upper link could have been contributed by failures of one or more of the other support links. (NOTE: Due to a scaling factor error under figure 25 (channels 348 and 349), the exact magnitude of peak loads are not correctly identified. The qualitative assessment of upper link performance was therefore, based upon the relative change in load.) Another indication of possible link failure may be seen by comparing the general forms of the compartment mass accelerations and link load data in figures 34 through 38. In figures 34 through 37, the range of the accelerations or loads are roughly the same before and after the implanted obstacle impact at about 4000 milliseconds. In figure 38, the range is much larger after impact than it was prior to impact. Again, either some links broke or the instrumentation on the lower support links failed at that time. Unfortunately, the fire devastated the area and made absolute determinations impossible.

FIGURE 33. SUPPORT LINK DATA WITH EXPANDED TIME SCALE

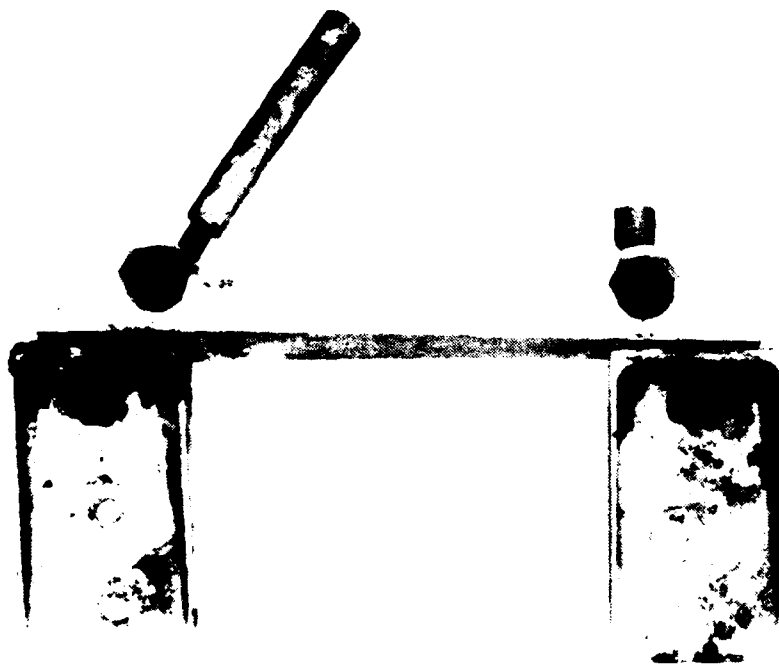
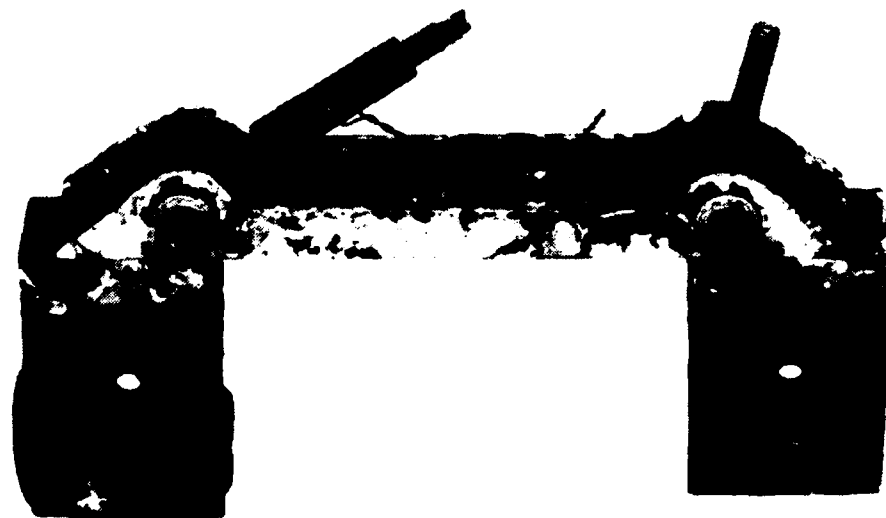
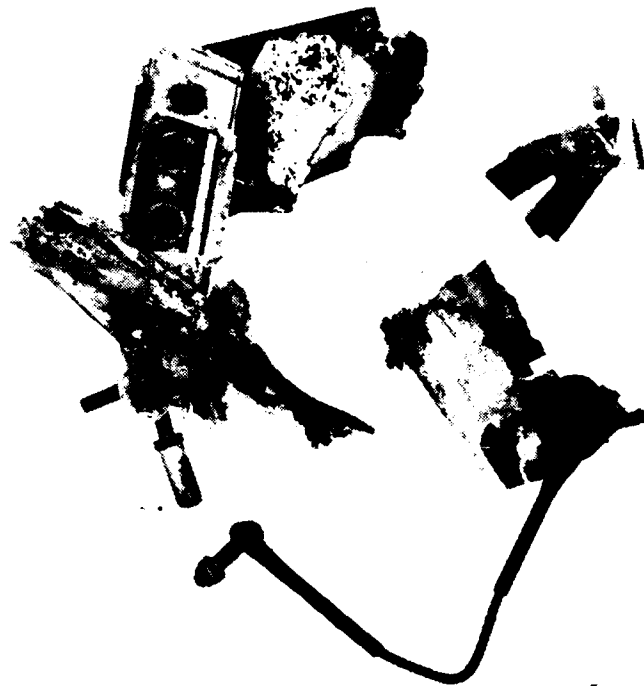
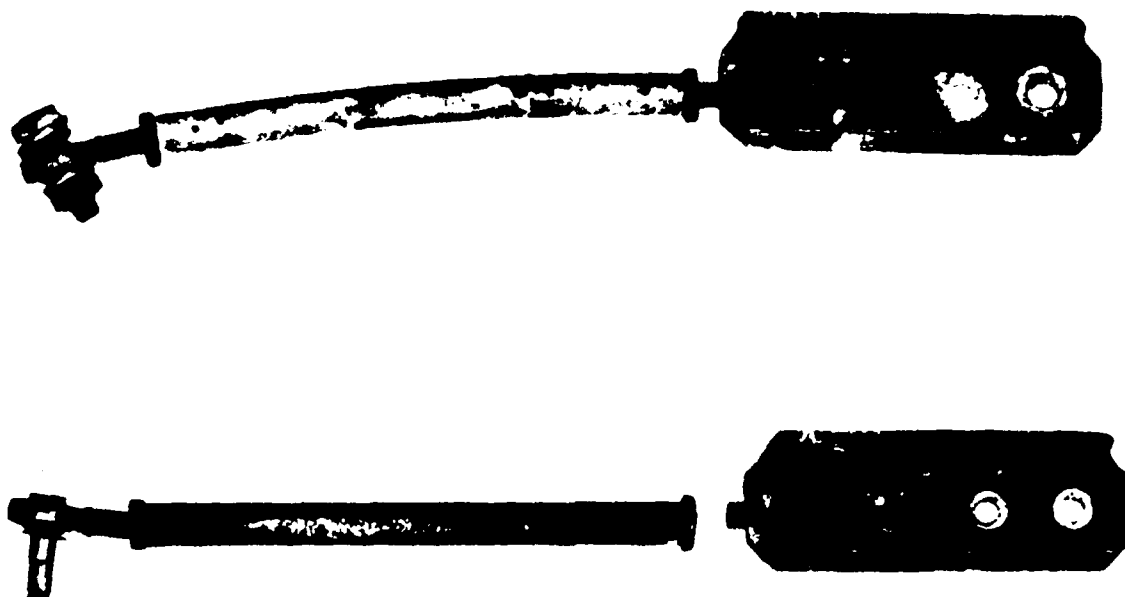
Visual/Macroscopic Examination: The remnants of seven support links were arranged in their relative positions in order to assess the loading and sequence of failure, as shown in Figures 1, 2, 3, and 4. Three links fractured in a plane perpendicular to the axial direction of the links through the holes in the unthreaded area. One link fractured in the same manner through the two small holes in the threaded area. In addition, two links failed through the eye-bolt attached to the threaded link. One of the seven links did not fail. The fractures in the failed links were relatively smooth and flat, as shown in Figure 5.

Analysis of Results: The results of this investigation indicate that the probable cause of failure in the six broken links was due to overheating caused by the fire after impact. Evidence of incipient melting at the grain boundary in all samples indicates that these support links were subjected to a temperature very close to the melting point of the material.

FIGURE A-1. FORWARD BIN, AFT UPPER SUPPORT BRACKET

FIGURE A-2. FORWARD BIN, FORWARD UPPER SUPPORT BRACKET

FIGURE A-3. AFT BIN, AFT UPPER SUPPORT BRACKET

FIGURE A-4. AFT AND FORWARD LOWER SUPPORT LINKS
